## CASE STUDY

### Emergency Response

**Veolia**

**Emergency Response  
Contract**

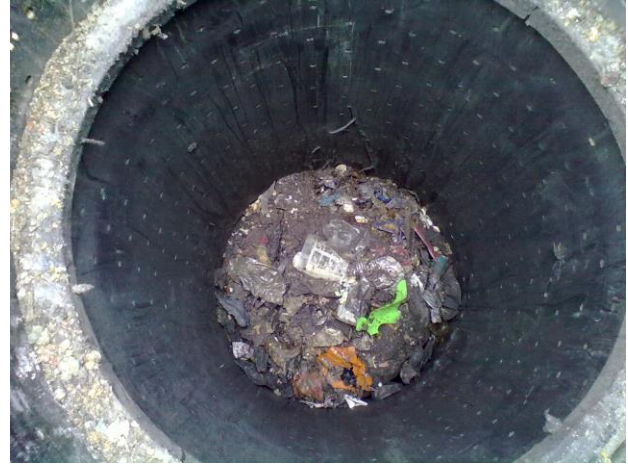
We performed a CCTV survey which revealed that a large section of the well had become molten plastic, yet appeared to be accessible within the well.

Using on-site excavators and our deep lift suction & hydraulic grabs, we created a safe platform which enabled us to remove the plastic, allowing for temporary operation of the manhole until full remedial works could be performed.

attachments and KCP in-house retrieval equipment, coupled with collaboration with other subcontractors, we successfully retrieved material

obstructing the chamber. We then assisted with the reconstruction of the well to allow the client to continue their core business of waste management. We were required to supervise, operate site equipment and liaise with others to achieve this task.
